Cracking-Induced Mistuning in Bladed Disks

Air Vehicles Division

Defence Science and Technology Organisation

Hou, J. (2005) Cracking-Induced Mistuning in Bladed Disks. In *Evaluation, Control and Prevention of High Cycle Fatigue in Gas Turbine Engines for Land, Sea and Air Vehicles* (pp. 37-1 – 37-12). Meeting Proceedings RTO-MP-AVT-121, Paper 37. Neuilly-sur-Seine, France: RTO. Available from: <http://www.rto.nato.int/abstracts.asp>.

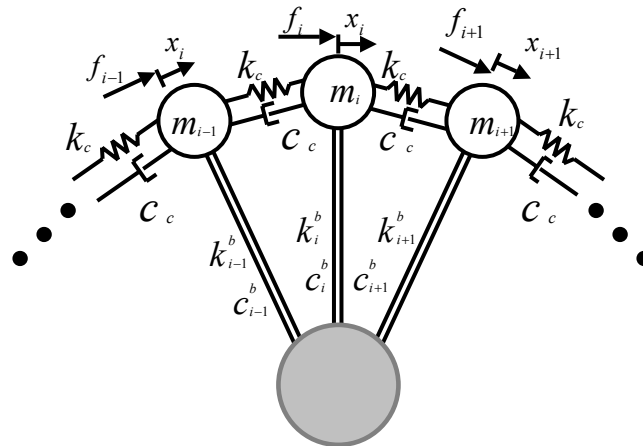
Figure 1. A lumped-mass-spring model of a bladed disk

A lumped-mass-spring model grounded using a massless beam was used as a baseline of a bladed disk without a crack as shown Figure 1.

This model has been used to study various aspects of mistuning in the literature and shown to be effective in capturing the essential dynamic characteristics of a mistuned bladed disk²⁻³. The equation of motion for the i^{th} mass representing the i^{th} blade ($i = 1, \dots, N$) can be described as:

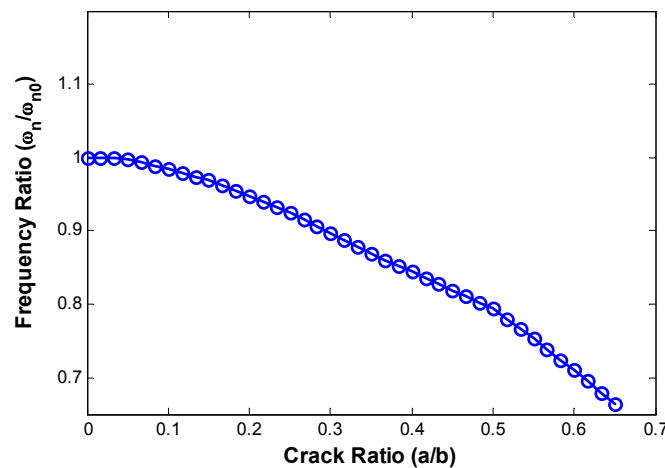
Figure 3. Relation between the fundamental frequency of a cracked blade and the crack length ratio

The effect of a cracked blade on mode localisation was investigated by considering different crack length ratios a/W , defined as the ratio between the crack length a and the blade root width W . a/W was in a range from 0.0 (without a crack) to 0.7 (the crack was 70% of blade width). The baseline model has the parameters of $b=85$ mm, $h=5$ mm, $l=170$ mm, $m=0.37$ kg. The relation between the fundamental frequency of a cracked blade and the crack length ratio was calculated using MatLab¹⁵, as shown in Figure 3. The frequency ratio is defined as the value of the fundamental frequency of a cracked blade normalised by the blade frequency without a crack. As expected, the frequency of a cracked beam decreased monotonically with increasing crack length ratio due to the fact that a crack in a blade introduces only local flexibilities, which is consistent with the observations in the literature⁷⁻¹¹.

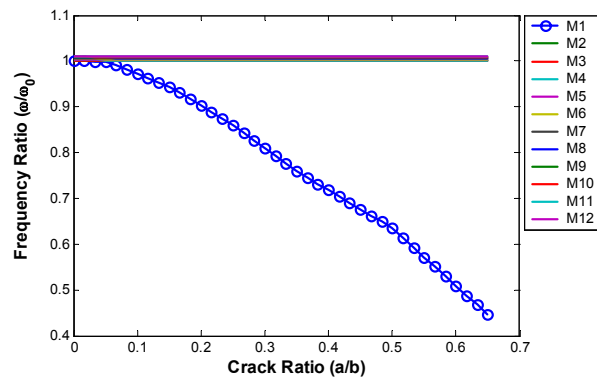
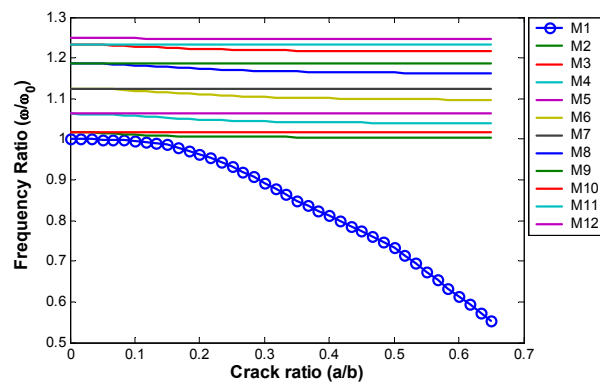
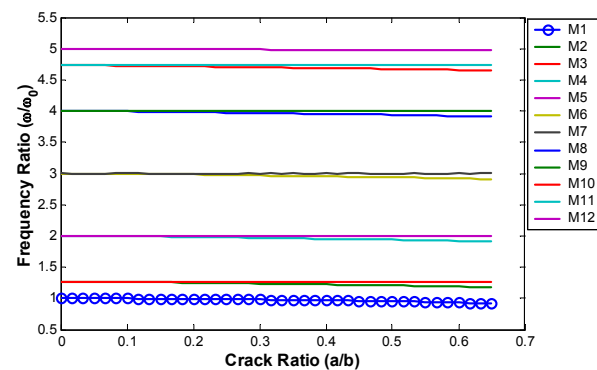
Figure 4. Variation of the 1st natural frequency with the crack length ratio

Figure 4 shows the relation between the natural frequencies of a 12 bladed disk and the crack length ratio. Three different disk-to-blade coupling ratios are considered, including weak coupling ($R=0.05$), moderate coupling ($R=0.25$) and strong coupling ($R=1$). The introduction of a crack mainly reduces the fundamental frequency of the bladed disk (one of a repeated pair) for both weakly and moderately coupled bladed disks. However, the reduction in the fundamental frequency is insignificant for a strongly coupled disk even if the crack length ratio is close to 0.7. For both weakly and moderately coupled bladed disks, the reduction in fundamental frequency is not noticeable when the crack length ratio is small, and only becomes significant when the crack length ratio is larger than 0.2. The fundamental natural frequency lowers dramatically after the crack length reaches 25% of the blade width. Note that the relation between a decrease in the fundamental frequency and the crack length ratio may not be considered as an eigenvalue loci veering phenomenon because of the monotonic decrease in the frequency with increase in the crack length ratio². Therefore a system for the blade crack detection relying on monitoring relative changes in frequency may not be sufficient for the weakly or moderately coupled bladed disks until the crack is larger enough (larger than 25% of the blade width). In the case of strong coupling, the change in frequency cannot be used as an indicator for the presence of crack even if the crack is quite long (70% of blade width in this case).

2. For both weakly and moderately coupled systems, the effect of a cracked blade is to reduce the natural frequencies monotonically, but the frequency reduction is insignificant when the crack length is small. With increase in crack length, only the fundamental frequency shows a dramatic reduction and the reductions in other frequencies are negligible. For a strongly coupled system, the reduction in natural frequencies is insignificant regardless of the values of crack length.

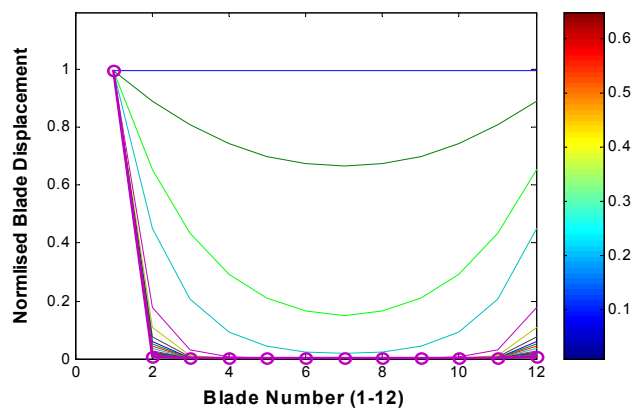
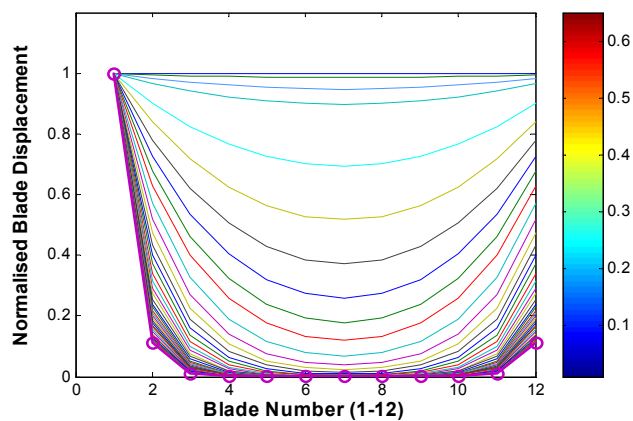
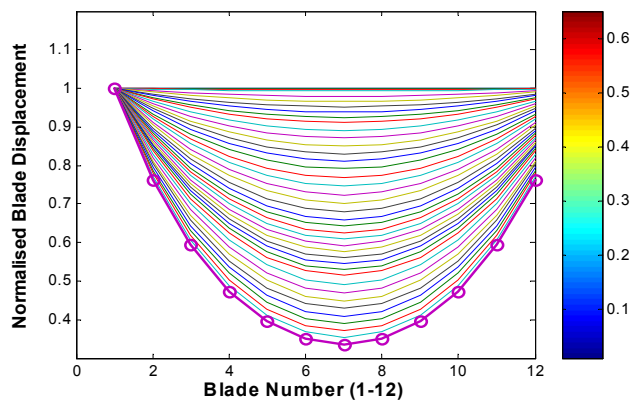
Figure 5. Mode variation with crack length ratio

The relation between the normalised mode shapes (to 1 for each mode) and the crack length ratio for the fundamental frequency is shown in Figure 5. The mode shape for the tuned case (based on a crack length ratio $a/W=0$) is a straight line corresponding to the zero nodal diameter. This straight line is gradually distorted with increase in the crack length for all three coupling ratios until the peak displacements are finally localised to the cracked blade (Blade 1). Note that variation rates differ for the different coupling ratios and are more sensitive in weakly and moderately coupled systems. Hence mode localisation occurs for all three coupling ratios although a weakly coupled system is more sensitive than the other two systems.

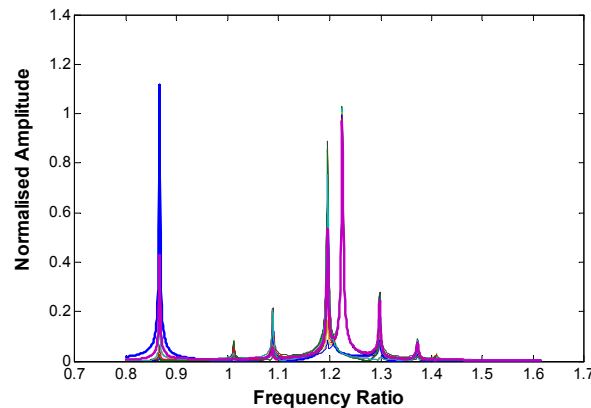
Figure 6. Frequency Response Amplitude of a bladed disk with a cracked blade ($E=3$, $R=0.25$, $a/b=0.05$)

The effect of the cracked blade on the blade response amplitude was investigated by performing frequency response analyses of the bladed disks with different crack ratios. Figure 6 shows typical vibration response amplitudes of the blades for a weakly coupled system, normalised to the maximum tuned amplitude. Clearly, mistuning has been introduced by a cracked blade.

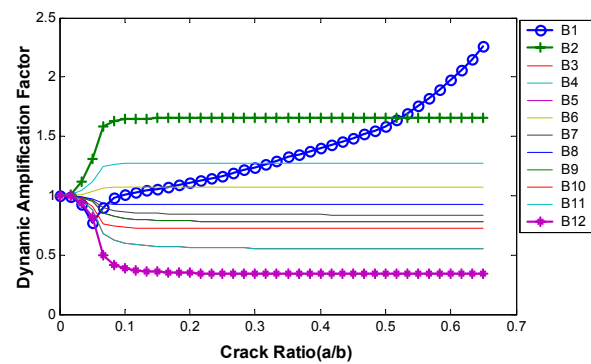
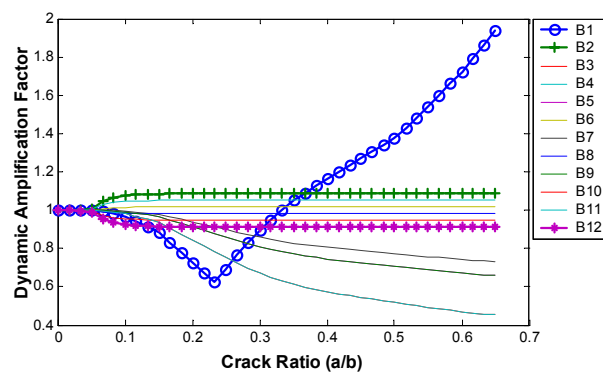
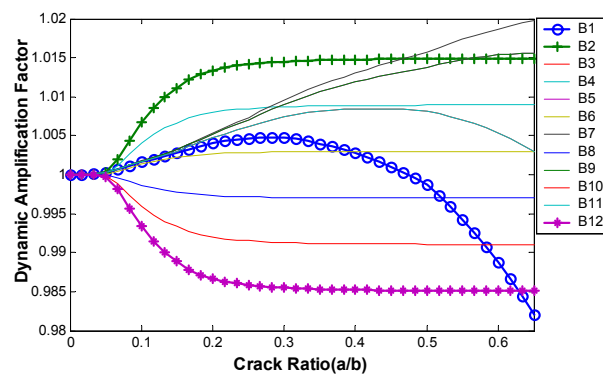
Figure 7. Frequency Response Amplitude of Each Individual Blade ($E=3$)

Figure 7 shows the normalised maximum response amplitudes for all 12 blades in the bladed disk under three coupling ratios. It is found that the response amplitude of the cracked blade (Blade 1) is less than those of other blades under all the three coupling ratios when the crack length ratio is small. For a weakly coupled system, the vibration amplitude of the cracked blade becomes larger than the amplitude of the adjacent maximum responding Blade 2 only when the crack length ratio approaches to a limit value of 0.55. For the moderately coupled system, the limit value of the crack length ratio is 0.35. However, the limit value is greater than 0.6 for the strongly coupled system. Therefore, the cracked blade does not necessarily experience the maximum response in all scenarios, and the maximum responding blade varies depending on the crack length ratio. This may impose significant difficulties for vibration-based crack detection techniques if only the maximum responding amplitude is sought.

Nevertheless, the response variations of the two blades adjacent to the cracked blade show an interesting trend. Blade 2 (with a phase lag of $2\pi E/12$) experiences the maximum response amplitude for the crack length ratios approximately less than 0.5 for all three coupling ratios. Blade 12 (with a phase advance of $2\pi E/12$) experiences the minimum response amplitudes for ratios less than 0.5 for a weakly or strongly coupled system. However, this trend is not apparent for a moderately coupled system. This suggests that the cracked blade is only likely to be the maximum responding blade when a crack is sufficiently large. When the crack is small, the response amplitudes of adjacent blades are better indicators for detecting the existence of a cracked blade. This finding has an important implication for vibration-based blade crack detection and prognostic analysis as the cracked blade can be related to the response signatures of only a few blades in the whole bladed disk. Also the detection of the changes in vibration levels is an essential indicator for crack detection rather than the absolute response amplitude. As a cracked blade inevitably introduces mode localization and associated mistuning to a bladed disk, a cracked blade can cause higher response amplitudes to uncracked

3. A cracked blade does not necessarily experience the maximum response under all of the three typical coupling ratios, and the maximum responding blade depends on both the crack length and the coupling ratio. However, the mistuning caused by a cracked blade may amplify the dynamic response of the other uncracked blades and may give rise to HCF damage for other blades in a bladed disk.

4. As the maximum responding blade varies with the coupling ratio and crack length, a cracked blade cannot be easily identified based on response amplitudes when the crack is small. However, the adjacent blades do show a significant change in response amplitude. The adjacent blade with a phase lag may have an increased response whilst the blade with a phase advance may show a lowered response. This provides the essential information for vibration-based blade crack detection and prognostic analysis, as the cracked blade can be related to the response signature of uncracked blades.
